2023  
**WATER  
QUALITY**  
ANNUAL REPORT

This report summarizes the 2023 water quality monitoring and testing by the City of Moncton water and wastewater staff for the Moncton/Riverview/Dieppe service area and outlines various initiatives designed for long term sustainability of the water supply and delivery system.

**2023 Annual Water Quality Report  
Moncton / Riverview / Dieppe**

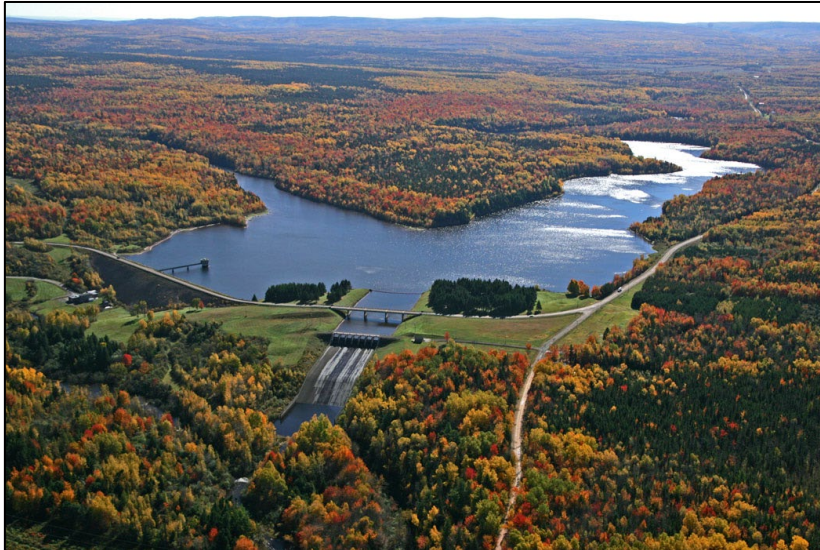
Figure 1: Aerial View of the Turtle Creek Reservoir

The primary water supply for the tri-community comes from the Turtle Creek watershed, a surface water supply, located southwest of Moncton. There are two large reservoirs in the watershed: the upper Tower Road Reservoir flows into the lower Turtle Creek Reservoir. Water from the Turtle Creek Reservoir is pumped from the reservoir to the Moncton Water Treatment Plant (WTP). Following treatment, water then flows by gravity to the communities of Moncton, Riverview, and Dieppe. Booster stations and storage tanks are required at several locations throughout the system to service higher elevations.

Due to the additional of a second dam in 2014 (Tower Road), as well as sufficient precipitation, no water shortages were experienced during 2023. Both the Tower Road and the Turtle Creek reservoirs were maintained at a near full condition throughout the year.

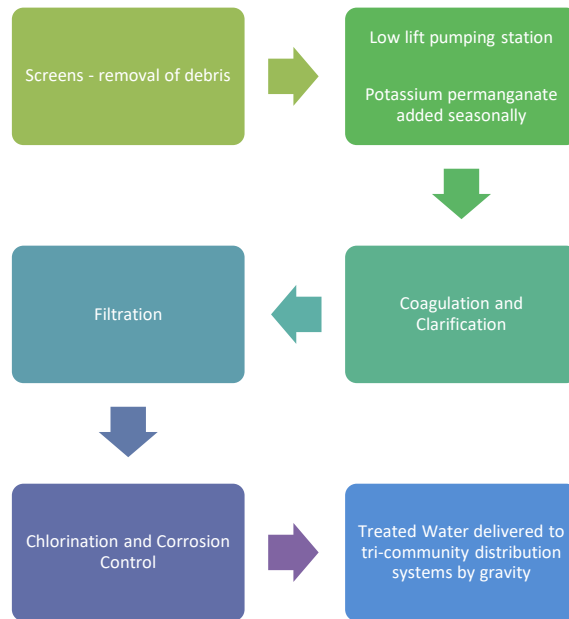
**Figure 2: Moncton's Water Treatment Plant Process**

Water from the Turtle Creek Reservoir passes through the plant removing turbidity, colour, iron, and manganese, and is then disinfected and adjusted chemically to protect against corrosion of metallic pipes.

The Multi-stage treatment process is described in more detail in the following sub-sections.

Before the raw water is pumped to the treatment plant, it flows through screens to remove any debris.

During the warmest months of the year, when the manganese and iron are at their highest, the raw water coming from the Turtle Creek Reservoir is first dosed with potassium permanganate. Potassium permanganate oxidizes iron and manganese, so they can be physically removed by the clarifiers and filters. Potassium permanganate also oxidizes organics that can cause taste and odour.

The next stage of the process is to add lime and alum to the raw water to help with particle removal. This process is called Coagulation. Just like a magnet attracts iron, alum draws particles together to form larger particles called *floc*. A polymer and microsand are also added to strengthen the floc and make it heavier before removal in the clarifiers and filters. As of the end of 2022, all four upflow adsorption clarifiers had been replaced with ballasted sand clarifiers.

The remaining floc is removed by filtration through gravity multi-media filters. The multi-media filters consist of three granular materials of different sizes and specific densities, layered in such a way to produce a filter that is coarse near the top of the bed and becomes progressively finer towards the bottom.

All the backwash water from the filters is sent to the solids handling facility, which consists of two large storage lagoons. Each lagoon has a detention time of one month. During that period, the solids in the water settle to the bottom and the clarified water eventually flows back into Turtle Creek. The solids accumulate in the lagoon for a period of several years before removal and final disposal at the sanitary landfill.

Following clarification and filtration, the water then enters the clearwell where the final stage of the treatment process takes place before the water is directed to the distribution system. Even with a very low turbidity, the water still needs to be disinfected against waterborne pathogens or infection- and disease-causing microorganisms.

Chlorine is added as a disinfectant to address viruses and bacteria, which can cause human illnesses. Sufficient chlorine is added to maintain a chlorine residual of 0.20 mg/L at the extremities of the distribution system.

As part of the on-going Corrosion Control Program that began in 1998, a corrosion inhibitor is added to the water. It is a food-grade ortho/polyphosphate blend that acts as a corrosion inhibitor in the distribution system. Also, as part of corrosion control, sodium hydroxide is added to neutralize the pH of the water.

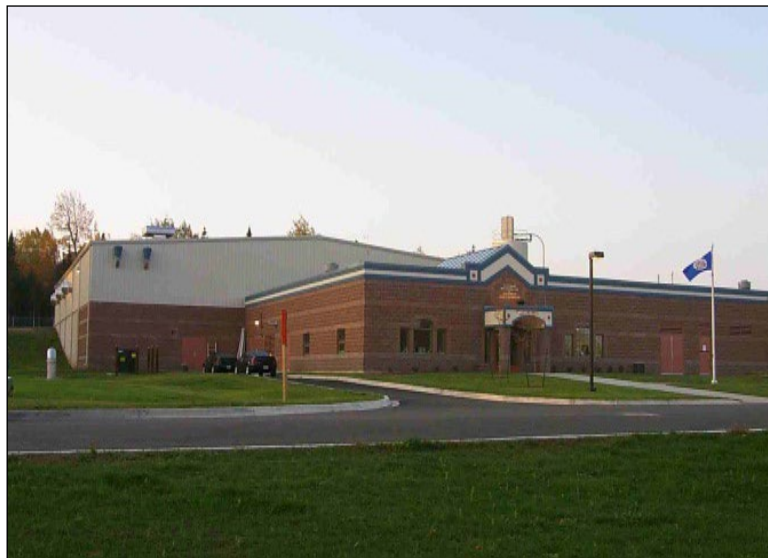
**Figure 3: Moncton Water Treatment Plant**

The Moncton Water Treatment Plant is a Class IV surface water treatment facility designed to provide an average daily flow of 68,200 cubic metres (15 million Imperial gallons) per day. The design capacity of the plant is 75,000 cubic metres (16.5 million Imperial gallons), and the peak (short-term) capacity of the plant is 113,670 cubic metres (25 million Imperial gallons).

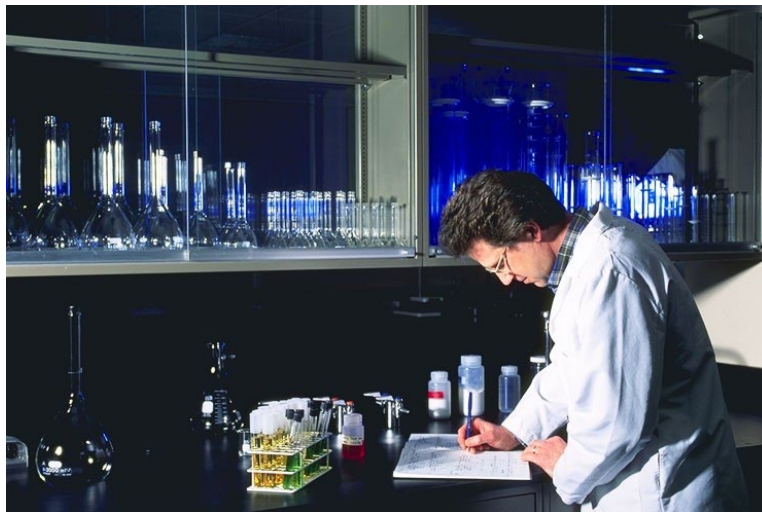
Figure 4: Water Quality Control

During 2023, turbidity levels were monitored weekly at 34 designated locations in the distribution systems, as well as the raw and treated water at the treatment facility. The average treated water turbidity, from about 1800 tests was 0.24 NTU. This very low turbidity indicates that high quality water is reaching consumers' taps in all three communities.

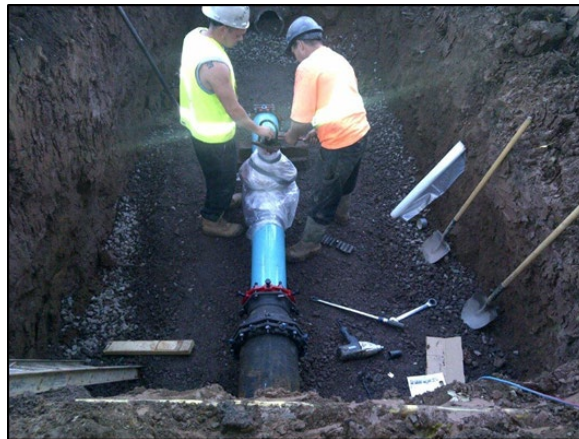
Figure 5: Water Main Valve Installation

In 2023, the City of Moncton upgraded approximately 3.25 km of existing water mains, including mains on Germain Street, Renfrew Street, Bessborough Avenue, Humphrey Street, Lynch Street, Atlantic Baptist Avenue, Blakeny Street, Gurney Drive, Lorne Street, Everett Street, Danforth Street, Peter Street, Somerset Drive, Fielding Street and Foundry Street.

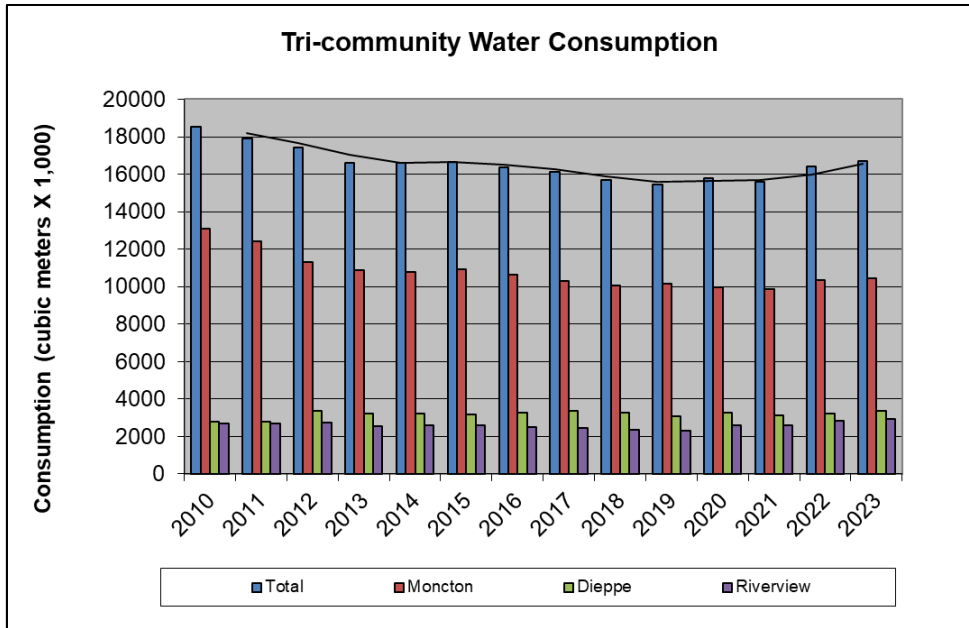
Figure 6: Tri-Community Water Consumption

Despite population growth, tri-community water consumption has generally been declining for a number of reasons. 2023 saw a modest 1.7% increase, reflecting the high precipitation levels experienced throughout the year. Water conservation initiatives, water saving appliances and fixtures, and smaller family sizes have all contributed to the reduction. In addition, Moncton has seen several large commercial users reduce consumption for various reasons.

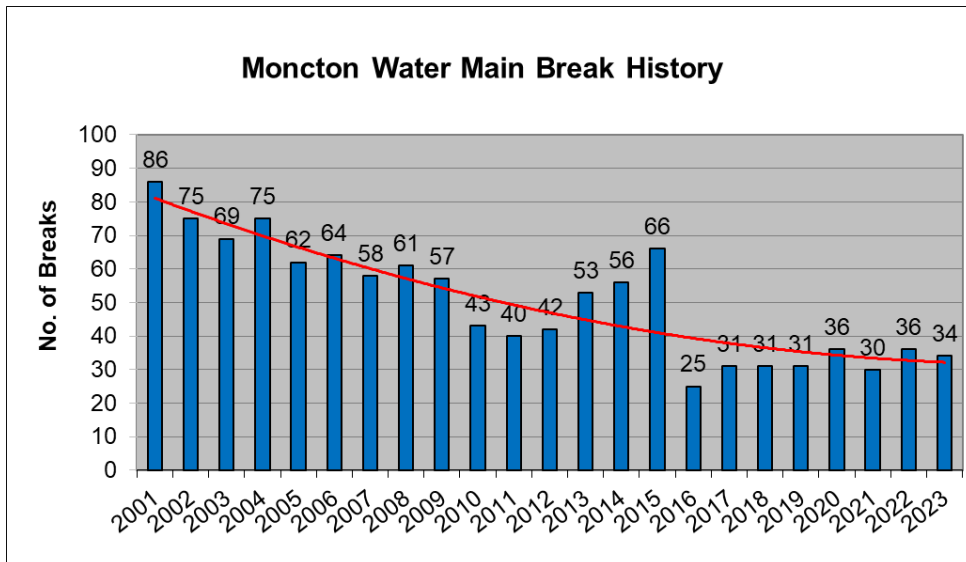
Figure 7: Water Main Break History

Over the past number of years, Moncton has accelerated its watermain replacement program by replacing “high break frequency” mains as well as older pipes. The charts below show the history of annual number of watermain and water service breaks/leaks. These illustrate the effectiveness of the city’s watermain replacement/rehabilitation program.

The significant reduction of watermain breaks and service leaks that the City of Moncton has experienced in the last few years is attributed to the investment in replacing or repairing high-break-frequency water mains.
